**Re: New Mexico State Police District 7 Headquarters; SIC 1542; Stormwater; Compliance
Evaluation Inspection; NPDES Permit NMU001940; August 9, 2017**

NPDES Compliance Inspection Report

New Mexico General Services Department
Project: NEW MEXICO STATE POLICE, DISTRICT 7 HEADQUARTERS
NPDES Compliance Evaluation Inspection
NPDES Permit NMU001940
August 9, 2017

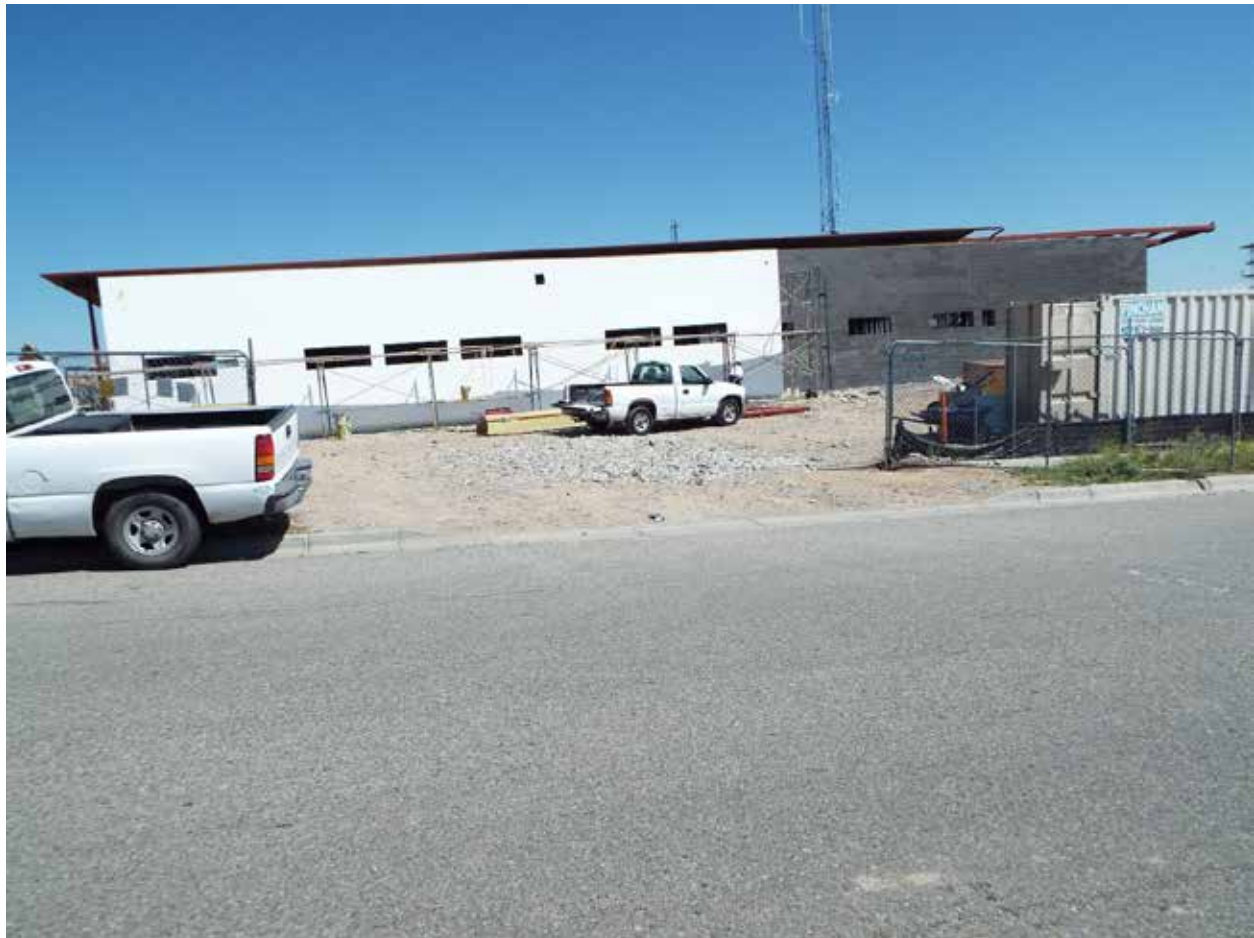
NMED/SWQB
OFFICIAL PHOTO LOG
PHOTO #1

Photographer: Daniel Valenta	Date: August 9, 2017	Time: 1046 Hours
City/County: Espanola/Rio Arriba		
Location: New Mexico State Police District 7 Headquarters		
Subject: On of two entrances on site. (southeast side)

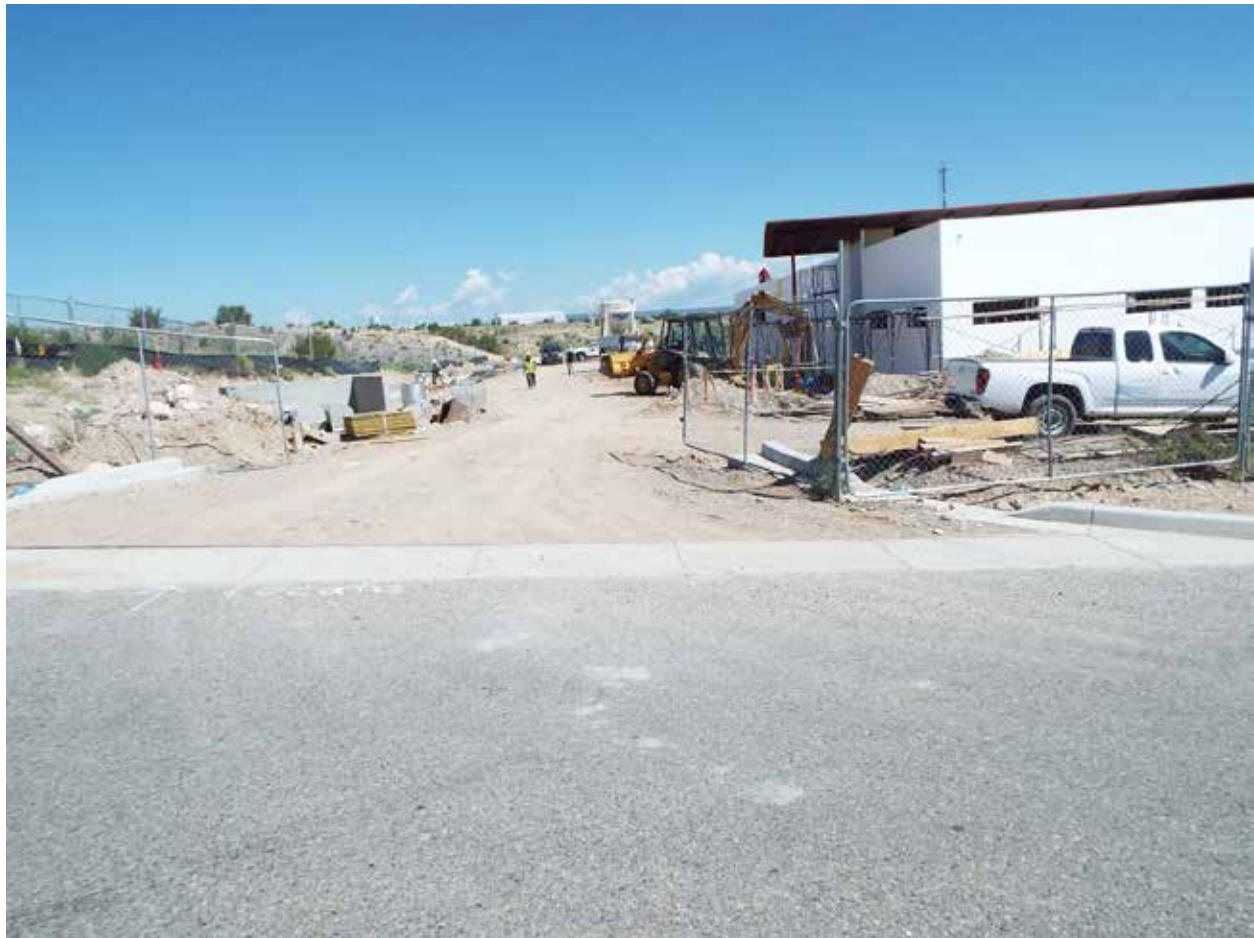
NMED/SWQB
OFFICIAL PHOTO LOG
PHOTO #2

Photographer: Daniel Valenta	Date: August 9, 2017	Time: 1046 Hours
City/County: Espanola/Rio Arriba		
Location: New Mexico State Police District 7 Headquarters		
Subject: On of two entrances on site. (southwest entrance) Part 2.2.4/Permit Requirements: Use appropriate stabilization techniques (e.g., use of aggregate stone with an underlying geotextile or non-woven filter fabric, and turf mats) at all points that exit onto paved roads.

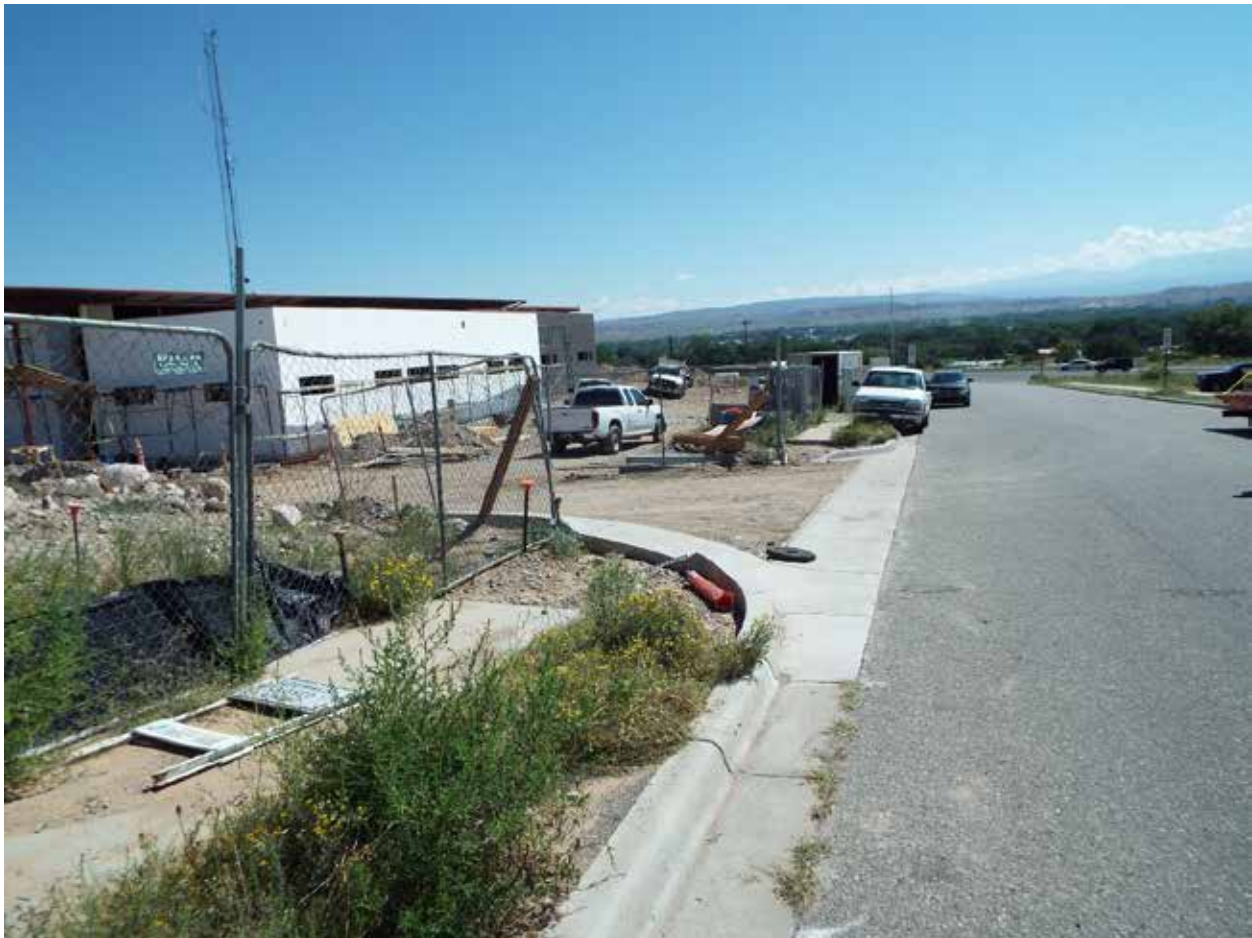
NMED/SWQB
OFFICIAL PHOTO LOG
PHOTO #3

Photographer: Daniel Valenta	Date: August 9, 2017	Time: 1046 Hours
City/County: Espanola/Rio Arriba		
Location: New Mexico State Police District 7 Headquarters		
Subject: On of two entrances on site. (southwest entrance) Part 2.2.4/Permit Requirements: Use appropriate stabilization techniques (e.g., use of aggregate stone with an underlying geotextile or non-woven filter fabric, and turf mats) at all points that exit onto paved roads.

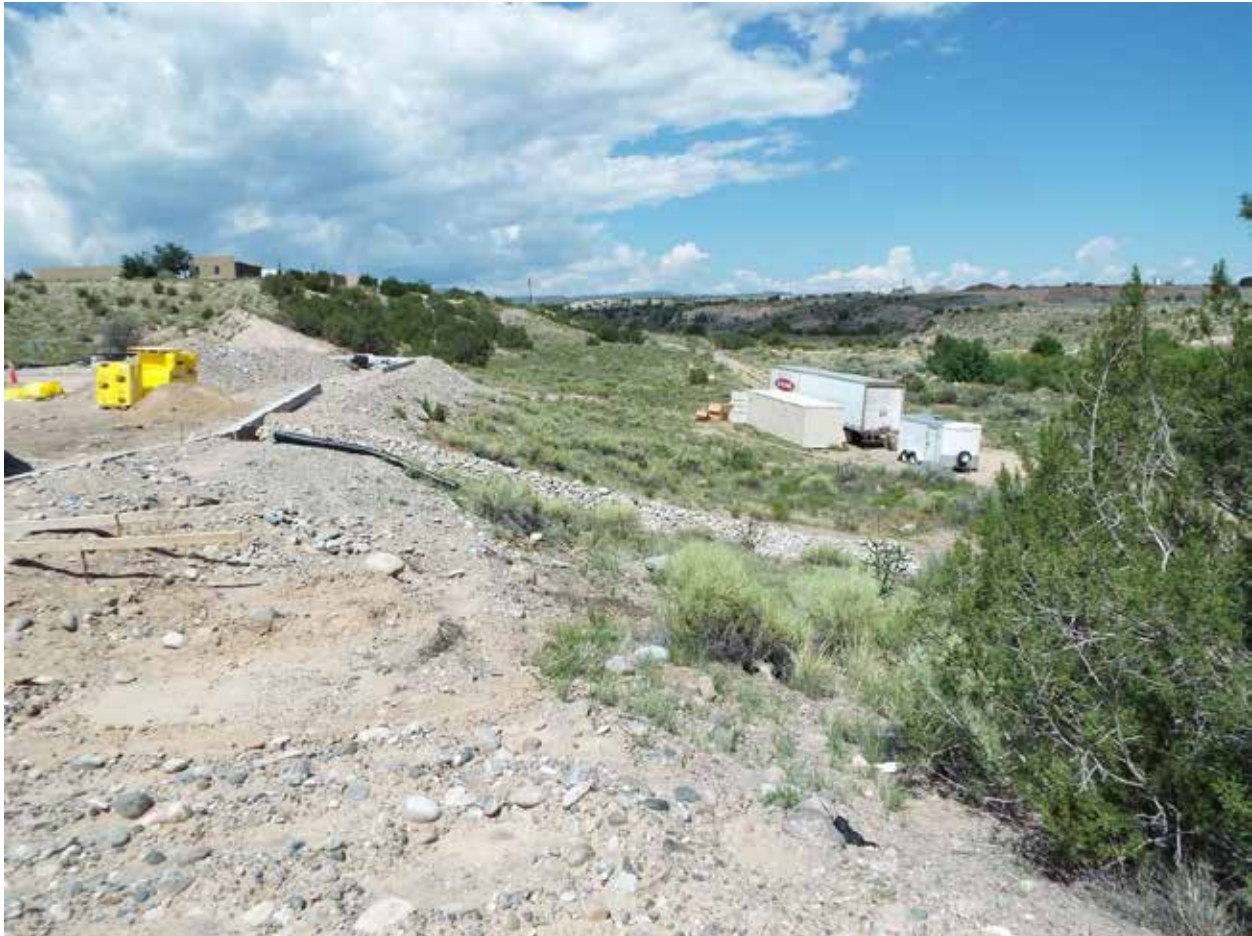
NMED/SWQB
OFFICIAL PHOTO LOG
PHOTO #5

Photographer: Daniel Valenta	Date: August 9, 2017	Time: 1046 Hours
City/County: Espanola/Rio Arriba		
Location: New Mexico State Police District 7 Headquarters		
Subject: North side of property looking west. Created spillway with curbing in place.

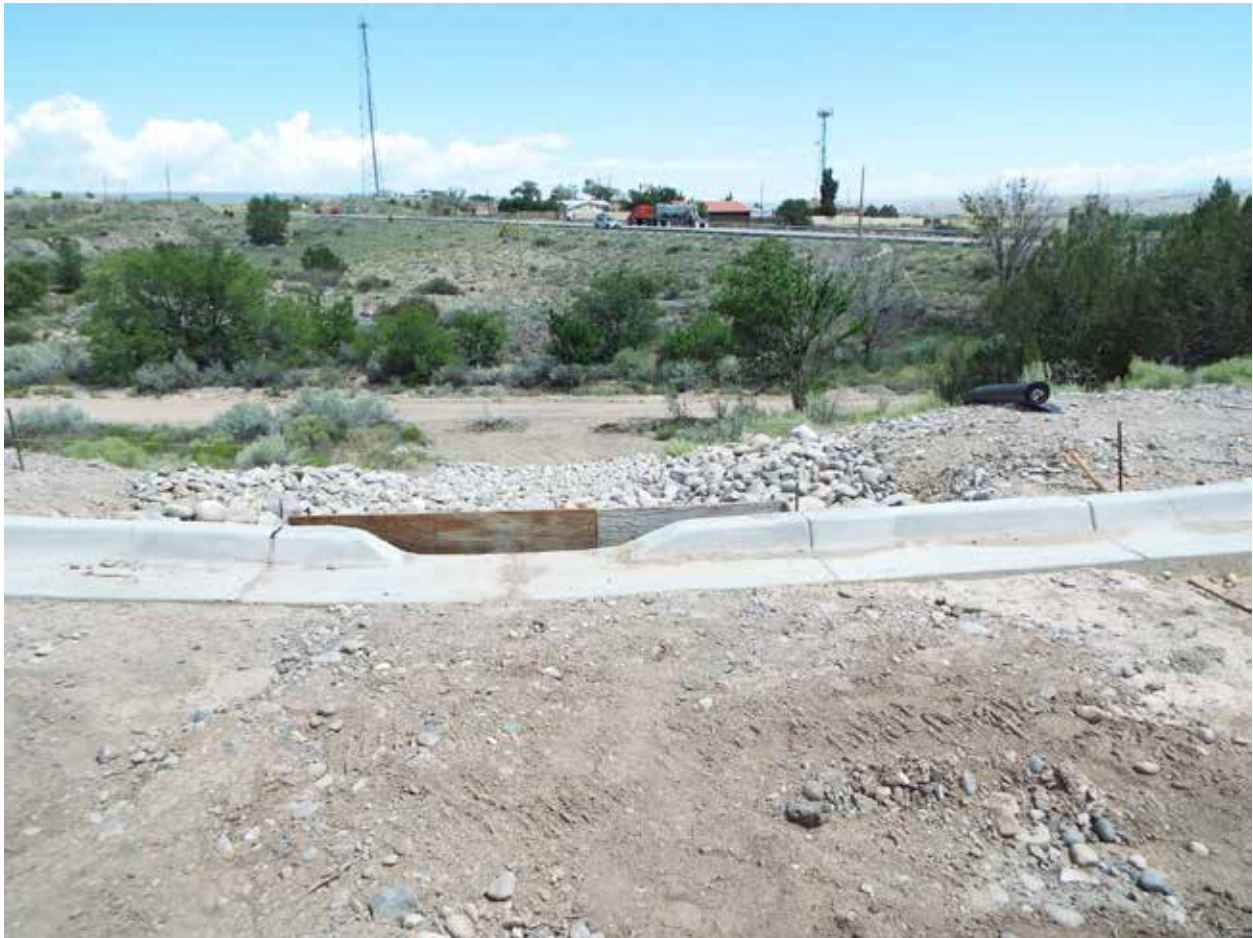
NMED/SWQB
OFFICIAL PHOTO LOG
PHOTO #6

Photographer: Daniel Valenta	Date: August 9, 2017	Time: 1138 Hours
City/County: Espanola/Rio Arriba		
Location: New Mexico State Police District 7 Headquarters		
Subject: North side of property looking north. Created spillway with curbing cutout for drainage purposes.

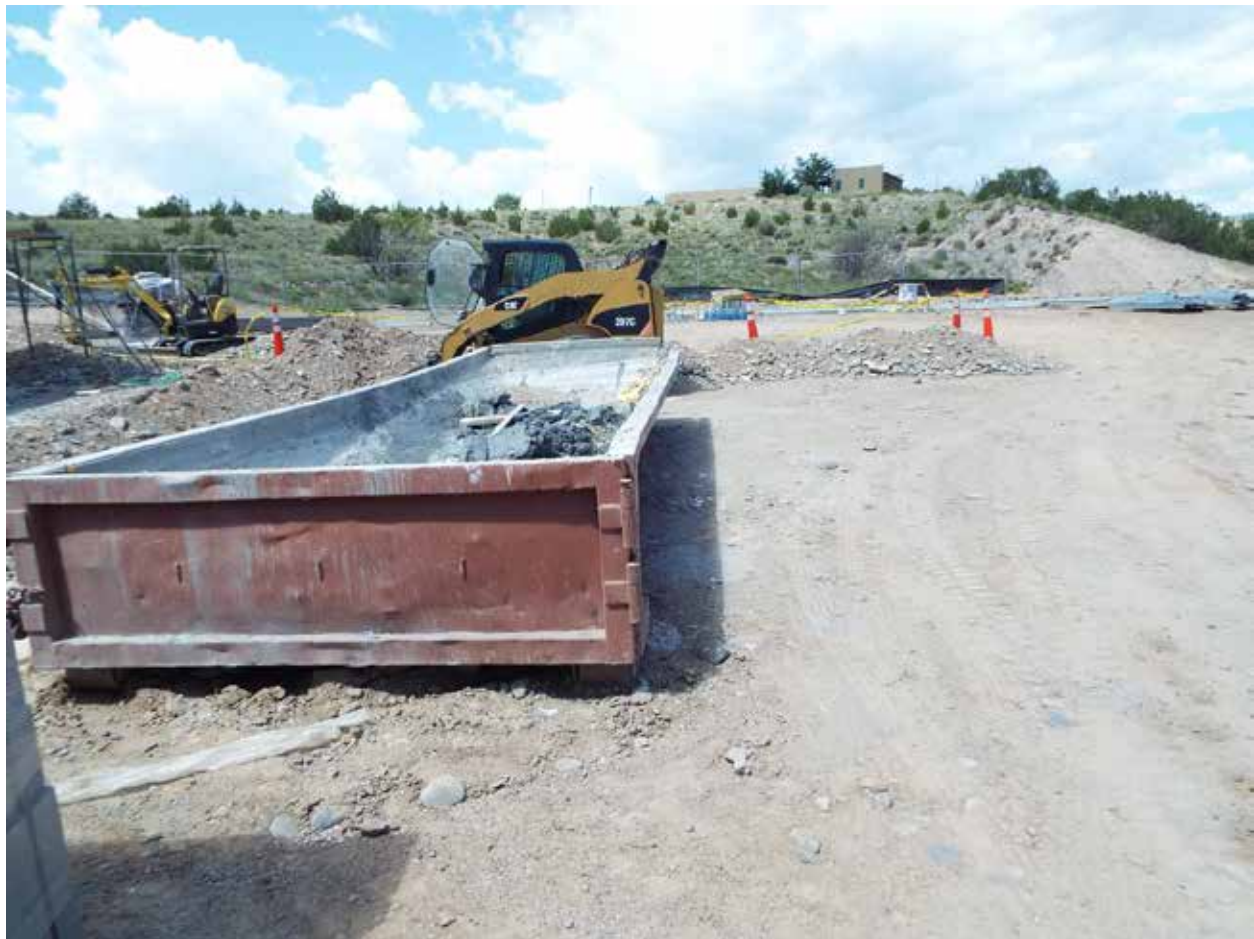
NMED/SWQB
OFFICIAL PHOTO LOG
PHOTO #9

Photographer: Daniel Valenta	Date: August 9, 2017	Time: 1138 Hours
City/County: Espanola/Rio Arriba		
Location: New Mexico State Police District 7 Headquarters		
Subject: Concrete washout container.

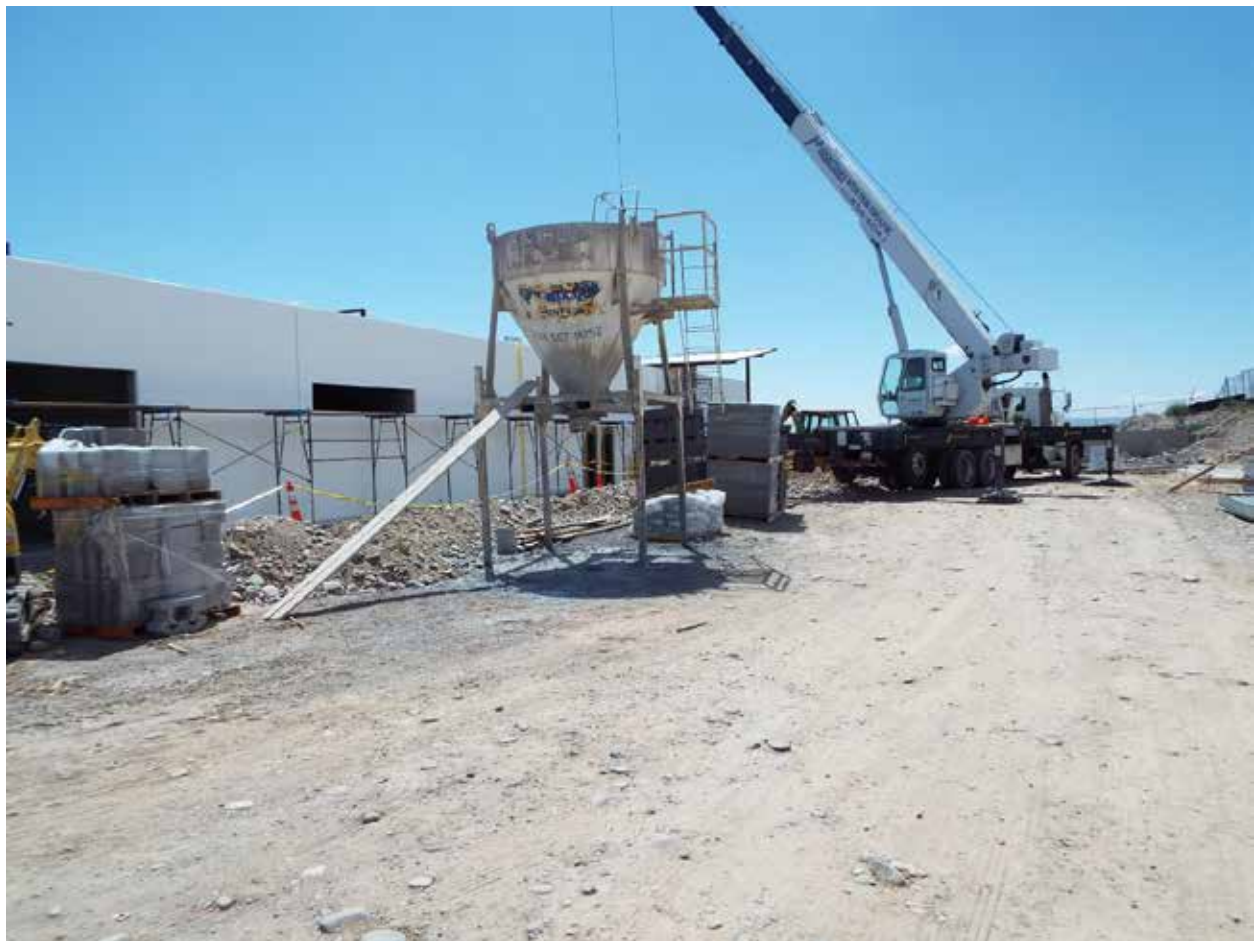
NMED/SWQB
OFFICIAL PHOTO LOG
PHOTO #10

Photographer: Daniel Valenta	Date: August 9, 2017	Time: 1143 Hours
City/County: Espanola/Rio Arriba		
Location: New Mexico State Police District 7 Headquarters		
Subject: Temporary Cement Plant west side of property / Part 2.3.4: Applicator and Container Washing Requirements: Direct washwater into a leak-proof container or leak-proof and lined pit designed so that no overflows can occur due to inadequate sizing.

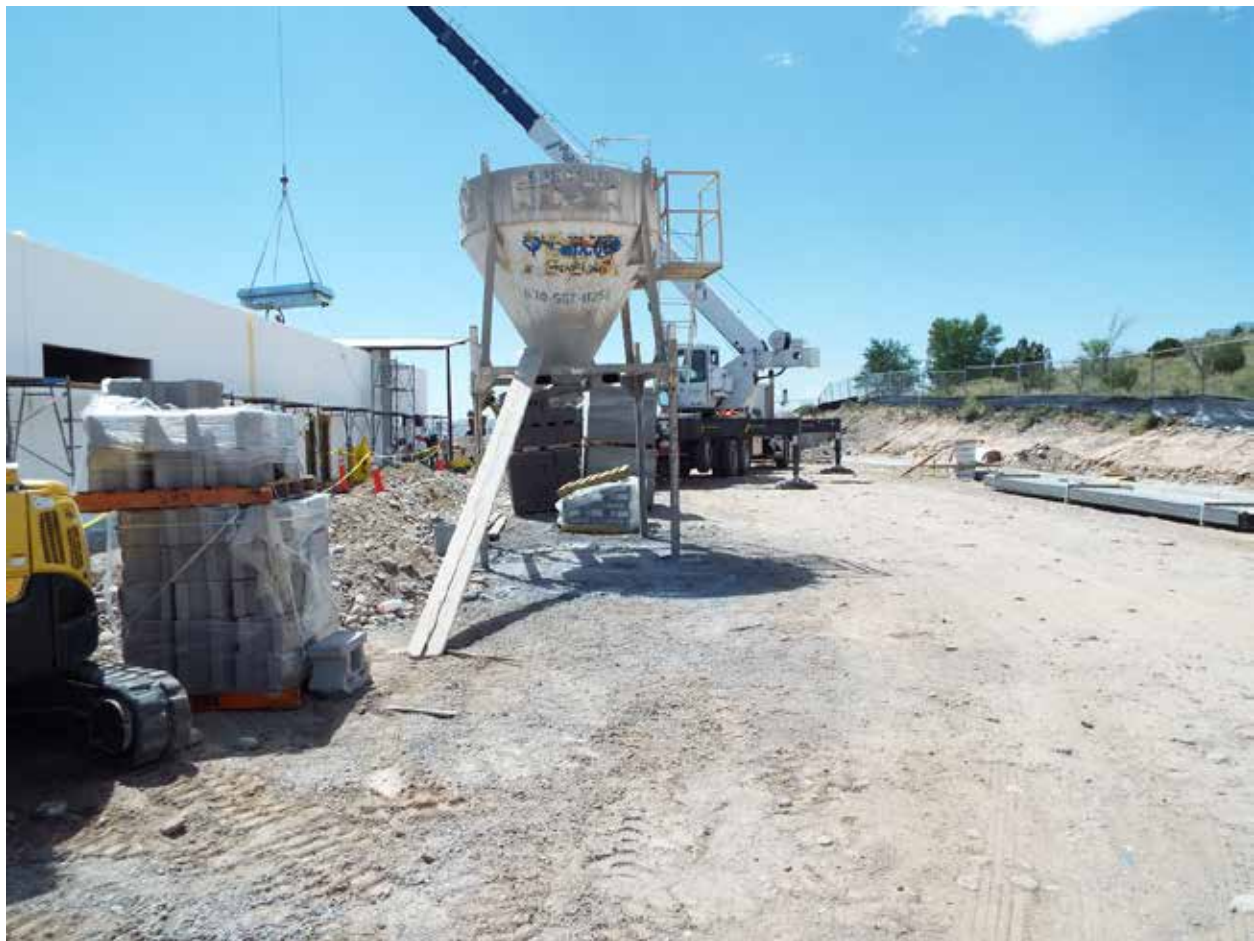
NMED/SWQB
OFFICIAL PHOTO LOG
PHOTO #11

Photographer: Daniel Valenta	Date: August 9, 2017	Time: 1143 Hours
City/County: Espanola/Rio Arriba		
Location: New Mexico State Police District 7 Headquarters		
Subject: Temporary Cement Plant west side of property / Part 2.3.4: Applicator and Container Washing Requirements: Direct washwater into a leak-proof container or leak-proof and lined pit designed so that no overflows can occur due to inadequate sizing.

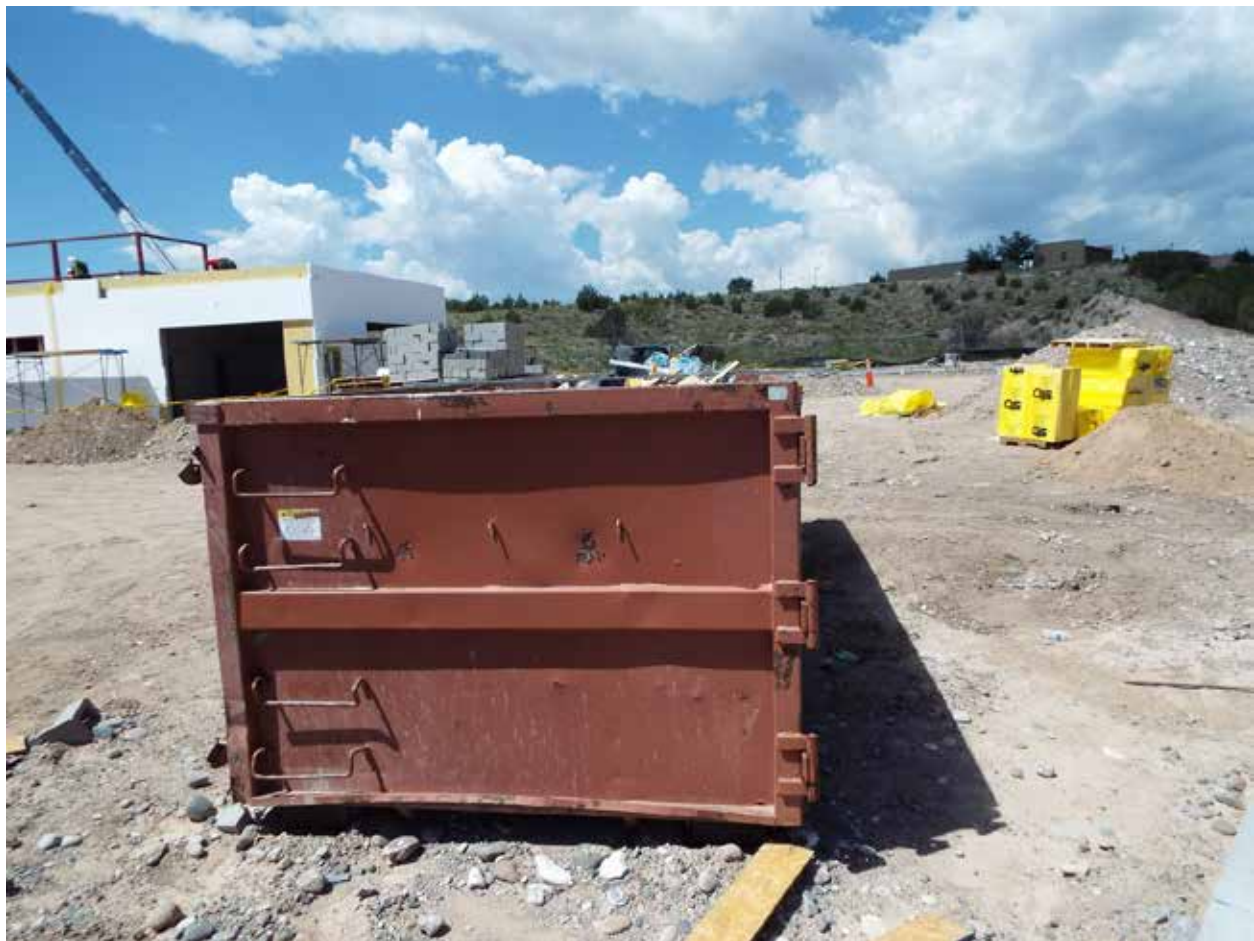
NMED/SWQB
OFFICIAL PHOTO LOG
PHOTO #12

Photographer: Daniel Valenta	Date: August 9, 2017	Time: 1137 Hours
City/County: Espanola/Rio Arriba		
Location: New Mexico State Police District 7 Headquarters		
Subject: Construction/Domestic trash dumpster / Part 2.3.3.e Requirements: For construction and domestic waste: Provide waste containers (e.g., dumpster, trash receptacle) of sufficient size and number. Keep waste container lids closed when not in use and close lids at the end of the business day for those containers that are actively used throughout the day.

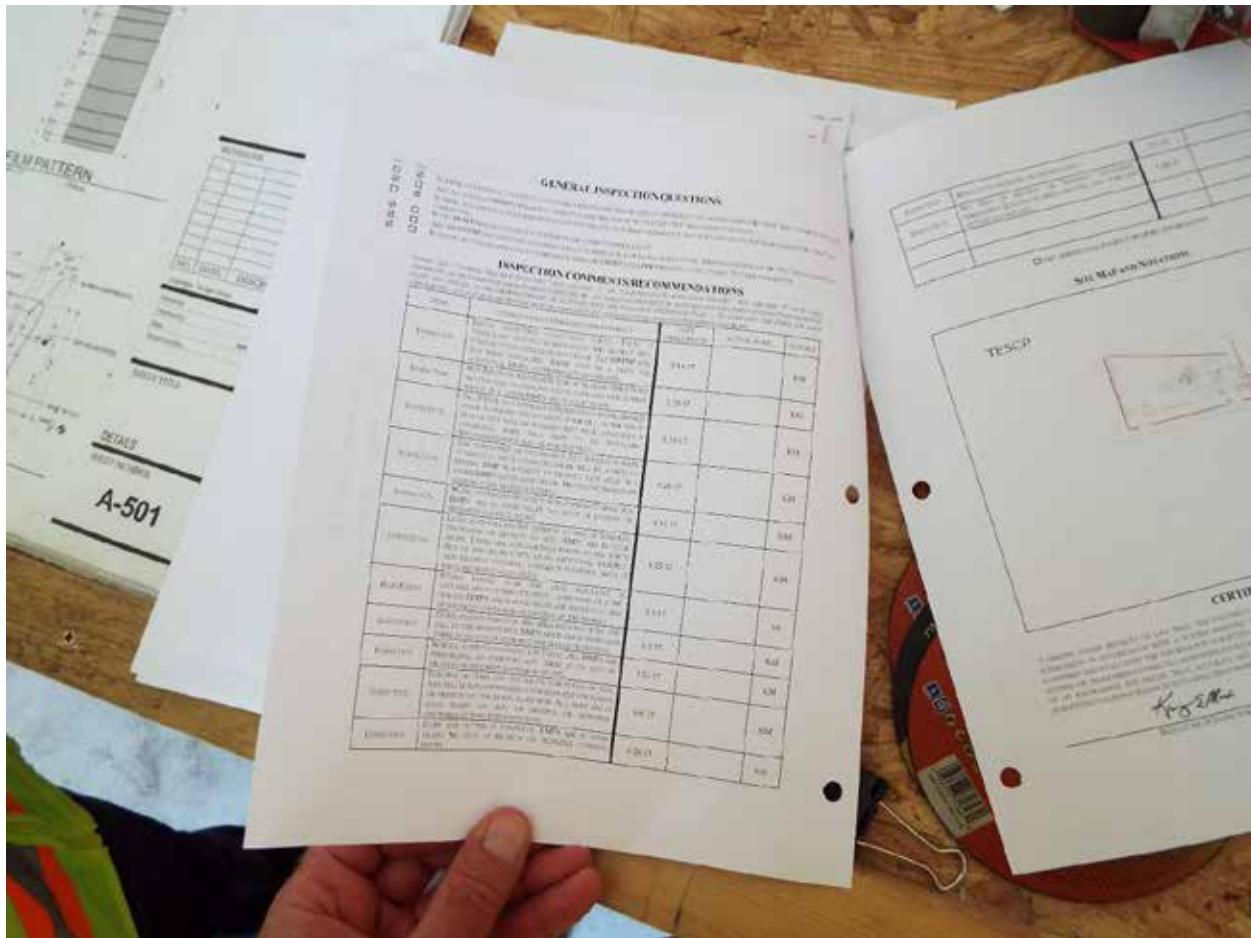
NMED/SWQB
OFFICIAL PHOTO LOG
PHOTO #13

Inspections, provided in the SWPPP, indicate that there was a precipitation event that occurred on May 1, 2017, with an accumulation of .58" of rain. There was not an inspection done 24-hours following this event, as required by the permit. The next inspection date of May 9, 2017.

Photographer: Daniel Valenta	Date: August 9, 2017	Time: 1132 Hours
City/County: Espanola/Rio Arriba		
Location: New Mexico State Police District 7 Headquarters		
Subject: Inspection report. Part 4.2 of Permit Requires: Inspect within 24 hours of the occurrence of a storm event of 0.25 inches or greater. (Rain event on May 1, 2017 of .58")
